**Flood Control Project Maintenance  
Levee Inspections**  
**LMA District Cover Sheet**  
**Spring 2017 Levee Inspection Results**

**Reclamation District No. 0524 Middle Roberts Island**

**Spring 2017 Levee Inspection Results**

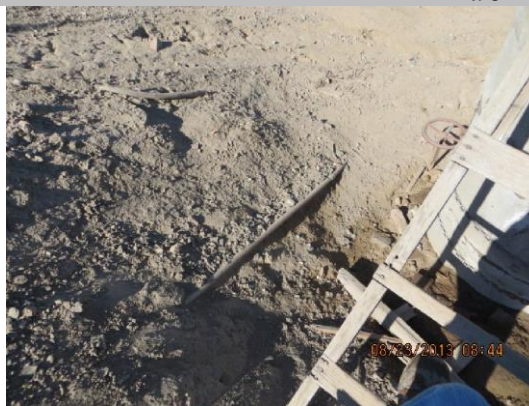
Photo 1 of 2 : UCIP\_SP\_2017\_22069\_37660.jpg

LM Start	4.17	Rating **	M	Issue No.	959
LM End	4.17	Issue Type +	En	Location *	LS
Category	Supplemental			GPS Latitude/Longitude	
				Start	End
Item	DWR UCIP Field Study			37.897074 °	37.897074 °
				-121.327926 °	-121.327926 °
DWR ID					
Comment Code					
Inspector Comment					
FS_ID:22069 DS_ID:24049 EP_NO: N/A Repair Type: Non-Urgent Crossing Status: Found UCIP Comments: No permit identified for this crossing. FIELD_STRUCT_DESC: 2.25-inch PVC domestic water service through the levee 5-feet below the crown. Pump and tank on WS slope with a vent on the LS slope. FS Date: 8/23/2013

Pipe visible on LS slope.

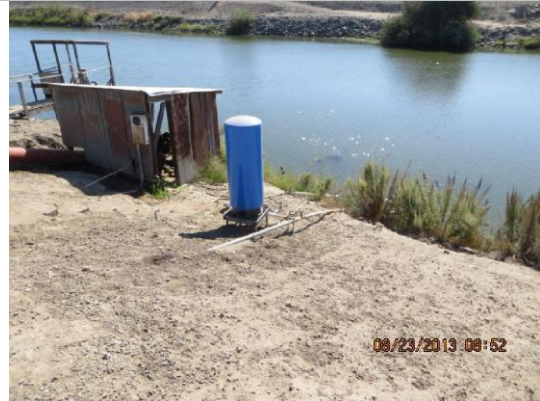
Photo 2 of 2 : UCIP\_SP\_2017\_22069\_37659.jpg

Pipe, pump, and tank visible on WS slope.

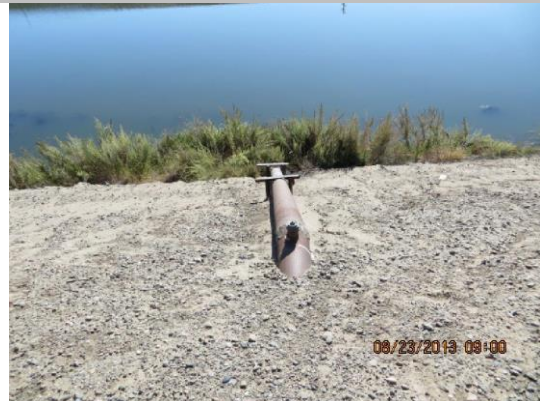
Photo 1 of 3 : UCIP\_SP\_2017\_18320\_30594.jpg

LM Start	4.37	Rating **	M	Issue No.	960
LM End	4.37	Issue Type +	Ma	Location *	LS
Category	Supplemental			GPS Latitude/Longitude	
				Start	End
Item	DWR UCIP LMA Responsibility			37.894453 °	37.894453 °
				-121.329232 °	-121.329232 °
DWR ID					
Comment Code					
Inspector Comment					
FS_ID:18320					
DS_ID:20626					
EP_NO: N/A					
Repair Type: Non-Urgent					
Crossing Status: Found					
UCIP Comments: Small leak in pipe on LS slope and pipe slightly crushed on LS toe.					
FIELD_STRUCT_DESC: 9-inch steel stormdrain pipe through the levee 3.0 feet below the crown, pump in drain ditch on the landward side.					
Siphon breaker on the waterward slope. Originally included in the 1964 O&M manual.					
FS Date: 8/23/2013

Pipe and siphon breaker on WS slope.

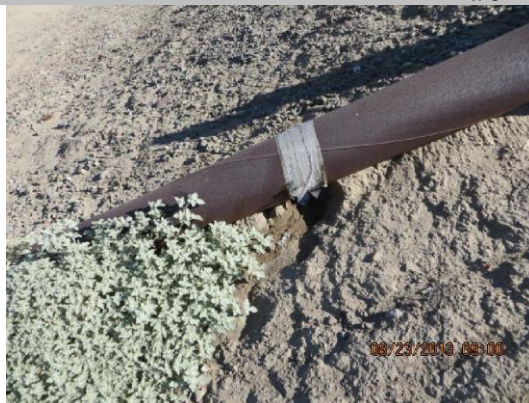
Photo 2 of 3 : UCIP\_SP\_2017\_18320\_30593.jpg

Small leak in pipe on LS slope.

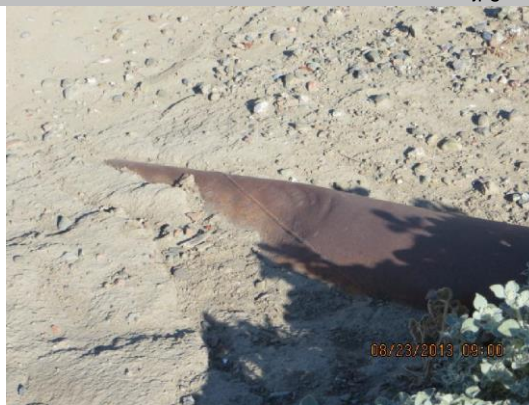
Photo 3 of 3 : UCIP\_SP\_2017\_18320\_30592.jpg

Pipe partially crushed at LS toe.

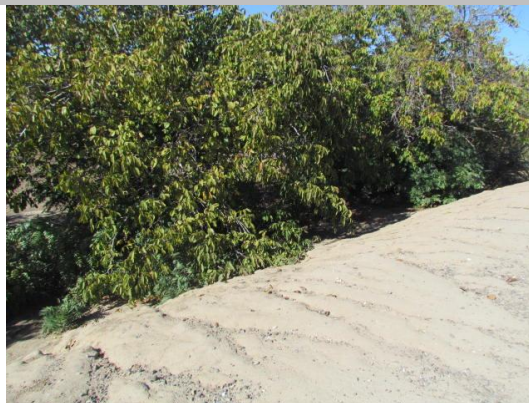
Photo 1 of 2 : SP\_2017\_RD0524\_107\_112\_20170316\_00171.jpg

LM Start	4.40	Rating **	U	Issue No.	112
LM End	4.53	Issue Type +	Ma	Location *	LS
Category	Earthen Levee			GPS Latitude/Longitude	
				Start	End
Item	Trim / Thin Trees			37.893928 °	37.892230 °
				-121.329203 °	-121.328187 °
DWR ID	DWR_RD0524_01_s_2012_112				
Comment Code					
T1 : Trim trees to at least five feet above ground level.					
Inspector Comment					
Untrimmed trees along landward slope and toe.

Looking northeast at untrimmed tree on landward slope and toe fall 2015.

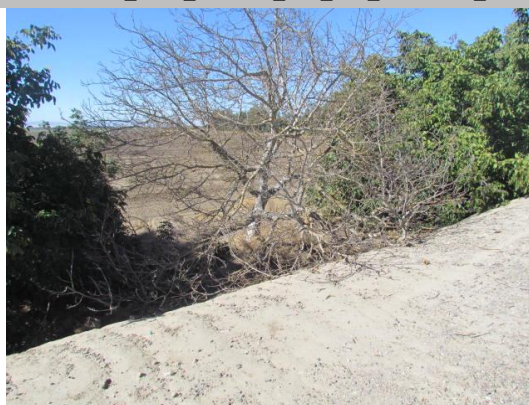
Photo 1 of 1 : SP\_2017\_RD0524\_107\_199\_20170316\_00230.jpg

LM Start	4.43	Rating **	U	Issue No.	199
LM End	4.43	Issue Type +	Ma	Location *	LS
Category	Earthen Levee			GPS Latitude/Longitude	
				Start	End
Item	Encroachments			37.893582 °	37.893582 °
				-121.329108 °	-121.329108 °
DWR ID	DWR_RD0524_01_f_2015_199				
Comment Code					
TR : Tree or limb					
Inspector Comment					
Remove dead tree from landward toe.

Looking west at dead tree on landward slope and toe fall 2015.

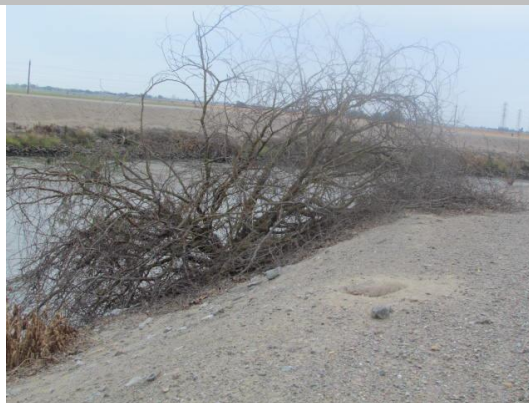
Photo 2 of 2 : SP\_2017\_RD0524\_107\_102\_20170316\_00163.jpg

Looking southeast at dead tree on waterside slope.

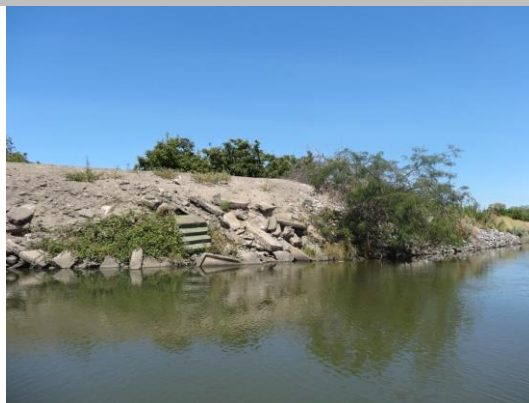
Photo 1 of 2 : SP\_2017\_RD0524\_107\_132\_20170316\_00187.jpg

LM Start	4.53	Rating **	U	Issue No.	132
LM End	4.54	Issue Type +	Ma	Location *	WS
Category	Supplemental			GPS Latitude/Longitude	
				Start	End
Item	DWR Erosion Survey			37.892230 °	37.892230 °
				-121.327930 °	-121.327930 °
DWR ID	DWR_RD0524_01_s_2017_132				
Comment Code					
Inspector Comment					
07/25/2016: No significant change observed.					
06/24/2015: No significant change observed.					
06/19/2014: No significant change observed.					
08/13/2013: No significant change observed.					
08/07/2012: The erosion is located at the inside of a river bend. Site is covered with broken concrete blocks and other debris. [2016 Site ID:RD0524U01RM45.07]

Front view of the site. Note the loosely placed concrete blocks at the site.

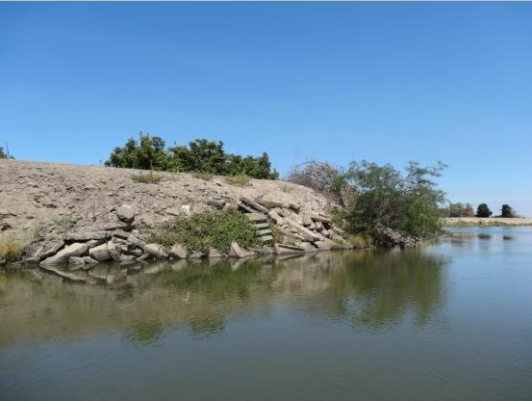
Photo 2 of 2 : SP\_2017\_RD0524\_107\_132\_20170316\_00188.jpg

Upstream view of the erosion.

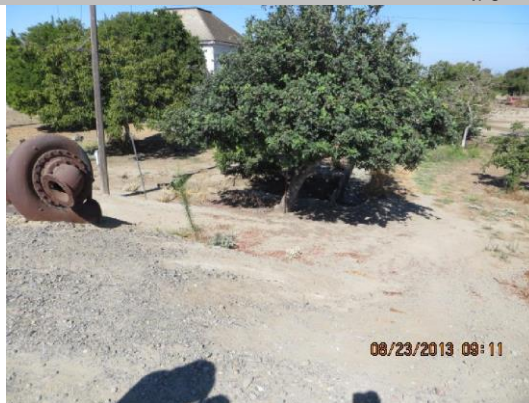
Photo 1 of 3 : UCIP\_SP\_2017\_18323\_30603.jpg

LM Start	4.68	Rating **	M	Issue No.	961
LM End	4.68	Issue Type +	En	Location *	LS
Category	Supplemental			GPS Latitude/Longitude	
				Start	End
Item	DWR UCIP Field Study			37.890313 °	37.890313 °
				-121.329405 °	-121.329405 °
DWR ID					
Comment Code					
Inspector Comment					
FS_ID:18323 DS_ID:20646 EP_NO: 0 Repair Type: Non-Urgent Crossing Status: Found UCIP Comments: Good candidate for video inspection as brick and mortar deteriorating inside tunnel. FIELD_STRUCT_DESC: 22-inch concrete pipe through the levee 12.0 feet below the crown. Pump on pier at WS toe. 16-inch pipe from pump discharges into a concrete riser inside the pumphouse on the WS shoulder. Brick and mortar channel on LS toe. Originally included in the 1964 O&M manual. FS Date: 8/23/2013

Brick and mortar channel on LS toe.

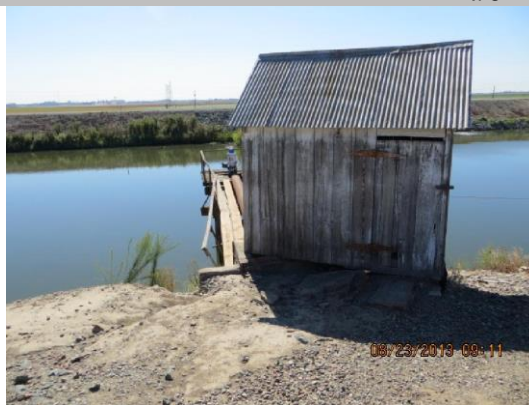
Photo 2 of 3 : UCIP\_SP\_2017\_18323\_30602.jpg

Pump on pier and slide gate house on WS shoulder.

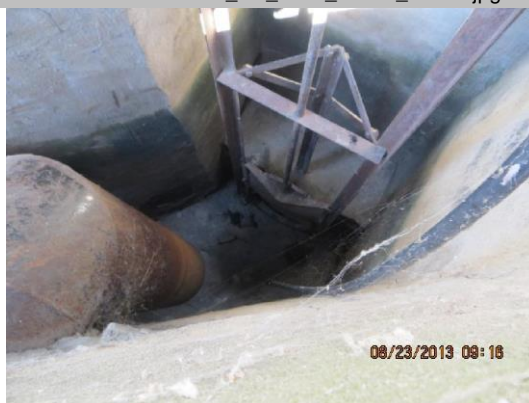
Photo 3 of 3 : UCIP\_SP\_2017\_18323\_30601.jpg

Slide gate inside concrete riser within shed on WS shoulder.

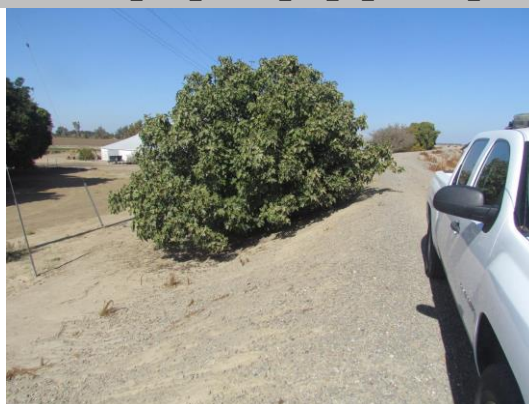
Photo 1 of 1 : SP\_2017\_RD0524\_107\_67\_20170316\_00111.jpg

LM Start	4.70	Rating **	U	Issue No.	67
LM End	4.70	Issue Type +	Ma	Location *	LS
Category	Earthen Levee			GPS Latitude/Longitude	
				Start	End
Item	Trim / Thin Trees			37.890108 °	37.890108 °
				-121.329523 °	-121.329523 °
DWR ID	DWR_RD0524_01_s_2012_67				
Comment Code					
T1 : Trim trees to at least five feet above ground level.					
Inspector Comment					
Fig tree at landside toe.

Looking northwest at untrimmed tree on landward slope.

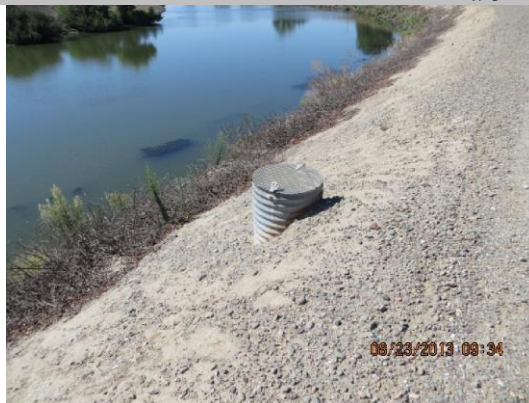
Photo 1 of 3 : UCIP\_SP\_2017\_22728\_38453.jpg

LM Start	4.89	Rating **	M	Issue No.	962
LM End	4.89	Issue Type +	En	Location *	LS
Category	Supplemental			GPS Latitude/Longitude	
				Start	End
Item	DWR UCIP Field Study			37.887694 °	37.887694 °
				-121.331019 °	-121.331019 °
DWR ID					
Comment Code					
Inspector Comment					
FS_ID:22728					
DS_ID:20628					
EP_NO: 3817					
Repair Type: Non-Urgent					
Crossing Status: Found					
UCIP Comments: Appears abandoned and if so should be done so properly.					
FIELD_STRUCT_DESC: *ABANDONED* 6-inch steel pipe through the levee 3.0 feet below the crown, pump 120-feet off the LS toe. Siphon breaker in 24-inch CMP on the waterward shoulder (Permit No. 3817)					
Originally included in the 1964 O&M manual.					
FS Date: 8/23/2013

Siphon breaker in 24-inch CMP riser on WS shoulder.

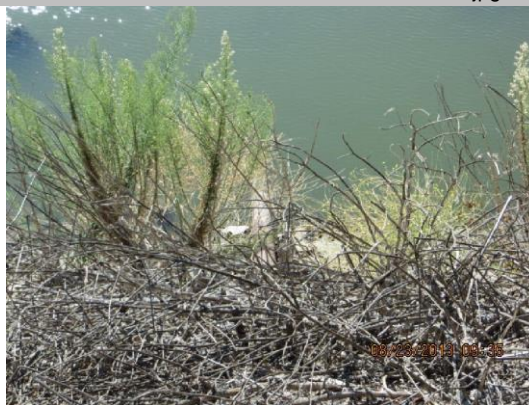
Photo 2 of 3 : UCIP\_SP\_2017\_22728\_38452.jpg

Pipe visible on WS toe.

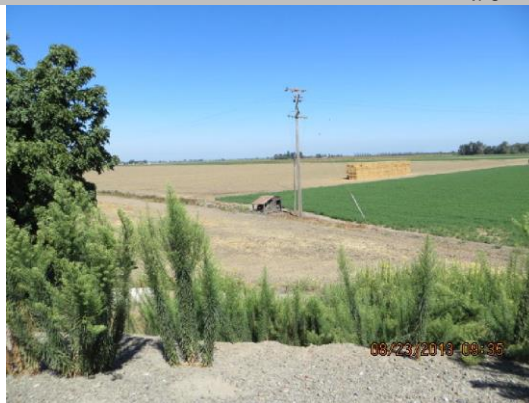
Photo 3 of 3 : UCIP\_SP\_2017\_22728\_38451.jpg

Pump in pumphouse 120-feet off LS toe.

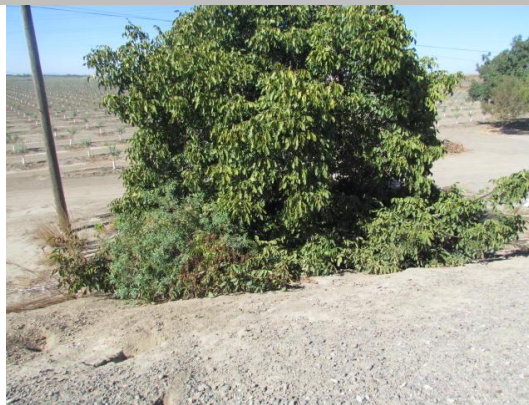
Photo 1 of 1 : SP\_2017\_RD0524\_107\_84\_20170316\_00138.jpg

LM Start	4.90	Rating **	U	Issue No.	84
LM End	4.93	Issue Type +	Ma	Location *	LS
Category	Earthen Levee			GPS Latitude/Longitude	
				Start	End
Item	Trim / Thin Trees			37.887655 °	37.887277 °
				-121.331202 °	-121.331609 °
DWR ID	DWR_RD0524_01_s_2012_84				
Comment Code					
T1 : Trim trees to at least five feet above ground level.					
Inspector Comment					
Untrimmed trees on landward slope.

Looking west at untrimmed tree on landward slope.

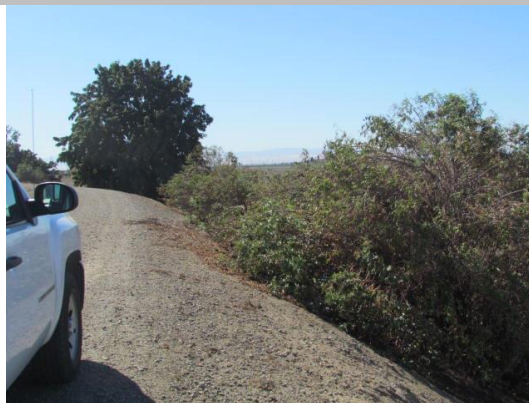
Photo 1 of 1 : SP\_2017\_RD0524\_107\_114\_20170316\_00174.jpg

LM Start	4.96	Rating **	U	Issue No.	114
LM End	4.98	Issue Type +	Ma	Location *	LS
Category	Earthen Levee			GPS Latitude/Longitude	
				Start	End
Item	Vegetation			37.886907 °	37.886673 °
				-121.331862 °	-121.331965 °
DWR ID	DWR_RD0524_01_s_2012_114				
Comment Code					
V4 : Elderberries are blocking visibility and flood fight capability.					
Inspector Comment					
Dense elderberry on landward slope.

Looking southwest at dense elderberry bush on landward slope and toe fall 2015.

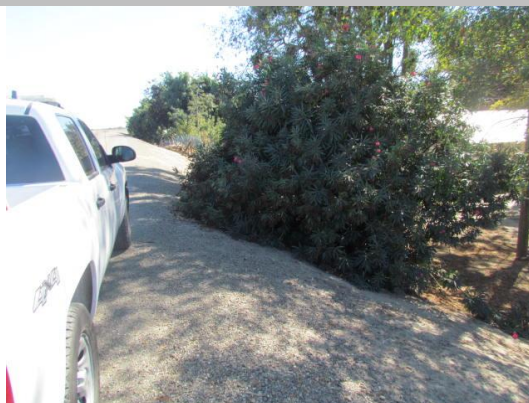
Photo 1 of 1 : SP\_2017\_RD0524\_107\_188\_20170316\_00221.jpg

LM Start	5.05	Rating **		Issue No.	188
LM End	5.17	Issue Type +	Ma	Location *	LS
Category	Earthen Levee			GPS Latitude/Longitude	
				Start	End
Item	Trim / Thin Trees			37.885617 °	37.883938 °
				-121.332143 °	-121.332130 °
DWR ID	DWR_RD0524_01_s_2014_188				
Comment Code					
T1 : Trim trees to at least five feet above ground level.					
Inspector Comment					
Untrimmed trees on landward slope and toe.

Looking south at oleander on landward slope.

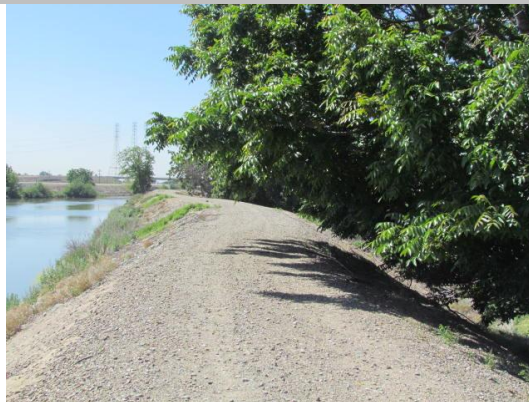
Photo 1 of 1 : SP\_2017\_RD0524\_107\_68\_20170316\_00112.jpg

LM Start	5.07	Rating **	U	Issue No.	68
LM End	5.07	Issue Type +	Ma	Location *	LS
Category	Earthen Levee			GPS Latitude/Longitude	
				Start	End
Item	Trim / Thin Trees			37.885400 °	37.885400 °
				-121.332153 °	-121.332153 °
DWR ID	DWR_RD0524_01_s_2012_68				
Comment Code					
T4 : Trim trees over roadway to at least 12 feet above ground level.					
Inspector Comment

Looking south at overhanging trees.

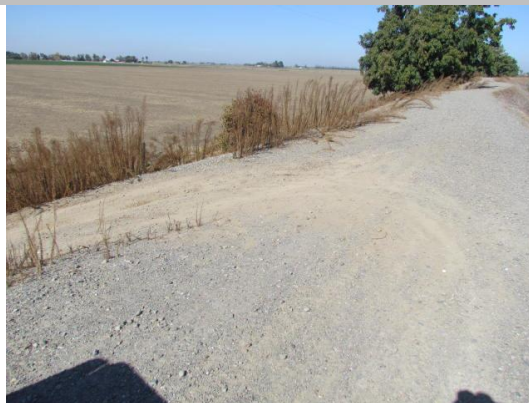
Photo 1 of 1 : SP\_2017\_RD0524\_107\_115\_20170316\_00175.jpg

LM Start	5.19	Rating **	M	Issue No.	115
LM End	5.19	Issue Type +	Ma	Location *	LS
Category	Earthen Levee			GPS Latitude/Longitude	
				Start	End
Item	Slope Stability			37.883587 °	37.883587 °
				-121.332100 °	-121.332100 °
DWR ID	DWR_RD0524_01_s_2012_115				
Comment Code					
S3 : Repair the levee slope damaged by vehicle traffic and prevent access where possible.					
Inspector Comment					
Vehicle traffic created a ramp on landward slope.

Looking northwest at slope damage on landward slope.

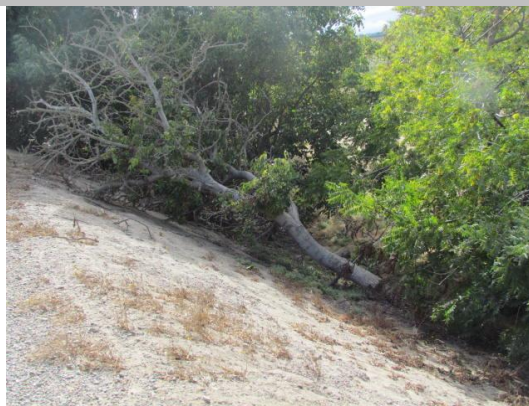
Photo 1 of 1 : SP\_2017\_RD0524\_107\_178\_20170316\_00211.jpg

LM Start	5.39	Rating **	M	Issue No.	178
LM End	5.39	Issue Type +	Ma	Location *	LS
Category	Earthen Levee			GPS Latitude/Longitude	
				Start	End
Item	Encroachments			37.880806 °	37.880806 °
				-121.332833 °	-121.332833 °
DWR ID	DWR_RD0524_01_f_2014_178				
Comment Code					
TR : Tree or limb					
Inspector Comment					
Downed tree on landward toe.

Looking south at downed tree on landward slope.

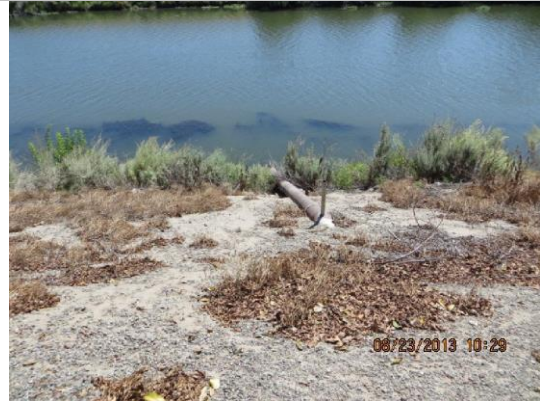
Photo 1 of 3 : UCIP\_SP\_2017\_51633\_30689.jpg

FS\_ID:51633  
DS\_ID:20630  
EP\_NO: N/A  
Repair Type: Urgent  
Crossing Status: Found  
UCIP Comments: 11/16/2016 same as previous inspection hole in pipe is still present on WS near toe. This pipe does not appear to be in use. Need to contact owner to determine status of crossing. If the crossing is abandoned or still in use, owner will need to coordinate with the CVFPB to comply with Title 23 requirements. (O. Magana - DWR UCIP)08/23/2013 flap gate damage and does not work at WS toe. Large hole in pipe at WS toe. Pipe appears abandoned and should be done so properly. (W. Wylie - DWR UCIP)  
FIELD\_STRUCT\_DESC: \*ABANDONED\* 1 of 2: 12-inch steel irrigation pipe (O&M references 10-inch pipe) through the levee, 6 feet below the crown. Pump located on waterside (WS), no pump found in 2013. Flap gate located on the WS end. [Additional Reference(s): DWR Levee Log, 2004. USACE San Joaquin River O&M Unit No. 7, April 1964, (HLM 5.48), Drawing No. 07-04-1490, sheet 1490/4, station 8+01.3]

Pipe visible on WS slope.

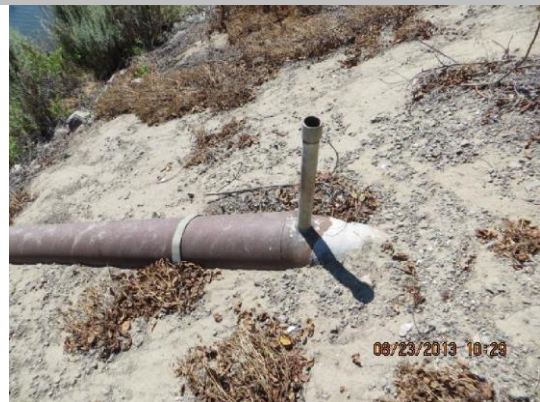
Photo 2 of 3 : UCIP\_SP\_2017\_51633\_30688.jpg

Vent on pipe on WS slope. Possible slurry standpipe that has not yet been used.

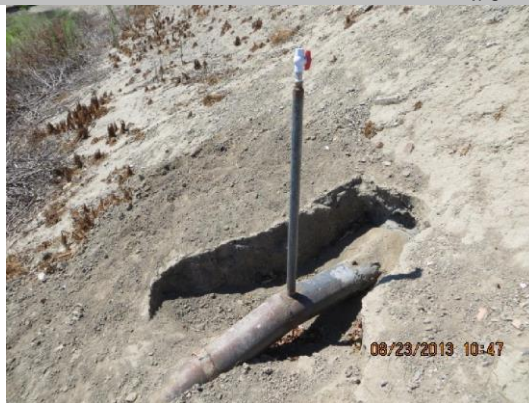
Photo 2 of 3 : UCIP\_SP\_2017\_18348\_30705.jpg

LM Start	5.42	Rating **	M	Issue No.	964 (cont)	
LM End	5.42	Issue Type +	Ma	Location *	LS	
Category	Supplemental			GPS Latitude/Longitude		
				Start	End	
Item	DWR UCIP LMA Responsibility			37.880358 °	37.880358 °	
				-121.332972 °	-121.332972 °	
DWR ID						
Comment Code						
Inspector Comment						
FS_ID:18348						
DS_ID:20631						
EP_NO: N/A						
Repair Type: Non-Urgent						
Crossing Status: Found						
UCIP Comments: Recent work being done on WS slope. Pipe may still be in use.						
FIELD_STRUCT_DESC: 10-inch steel storm drain pipe through the levee 6.0 feet below the crown. Pump not found on LS. Originally included in the 1964 O&M manual.						
FS Date: 8/23/2013

8-inch pipe sleeved through 10-inch pipe with vent on WS slope.

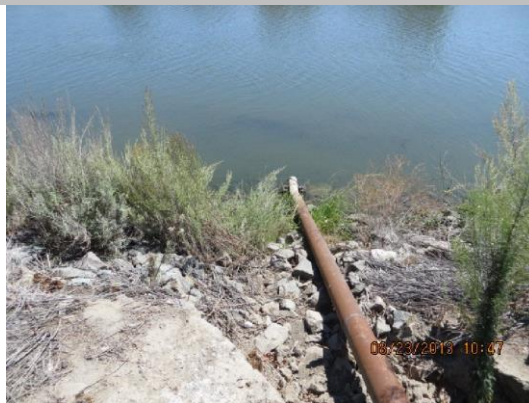
Photo 3 of 3 : UCIP\_SP\_2017\_18348\_30704.jpg

No flap gate on end of pipe at WS toe.

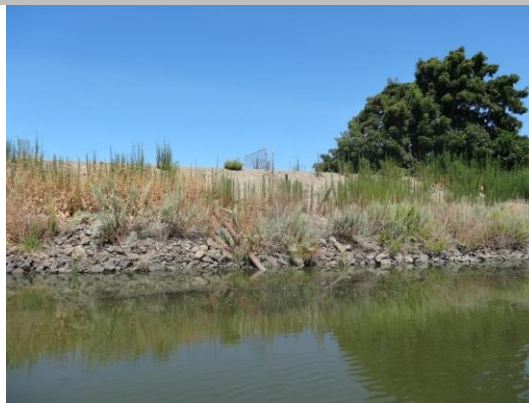
Photo 1 of 2 : SP\_2017\_RD0524\_107\_134\_20170316\_00189.jpg

LM Start	5.43	Rating **	U	Issue No.	134
LM End	5.43	Issue Type +	Ma	Location *	WS
Category	Supplemental			GPS Latitude/Longitude	
				Start	End
Item	DWR Erosion Survey			37.880320 °	37.880320 °
				-121.333266 °	-121.333266 °
DWR ID	DWR_RD0524_01_s_2017_134				
Comment Code					
Inspector Comment					
07/25/2016: No significant change observed. 06/24/2015: No significant change observed. 06/19/2014: No significant change observed. 08/13/2013: The erosion seems to be getting worse. More material sloughing visible. 08/07/2012: The erosion is underneath an irrigation pipe. The likely cause of the erosion is the pipe leakage. [2016 Site ID:RD0524U01RM45.97]

Close view of the erosion and the pipe on the site.

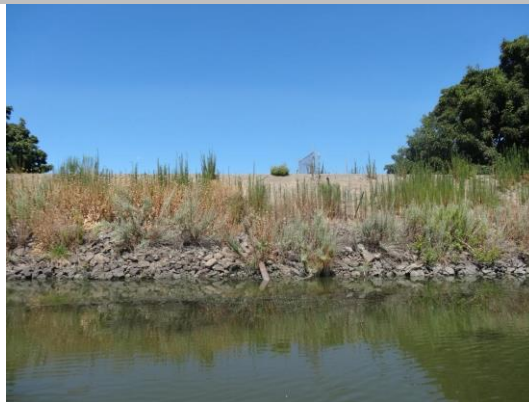
Photo 2 of 2 : SP\_2017\_RD0524\_107\_134\_20170316\_00190.jpg

Front view of the site.

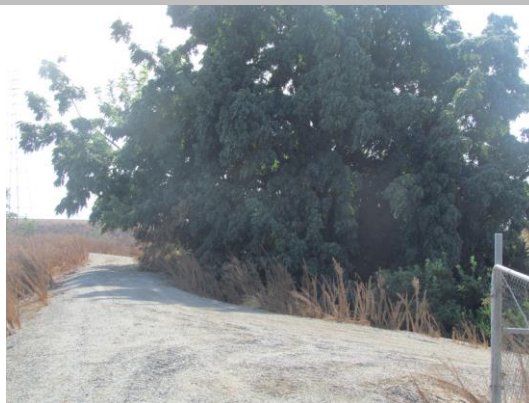
Photo 1 of 1 : SP\_2017\_RD0524\_107\_73\_20170316\_00118.jpg

LM Start	5.44	Rating **	U	Issue No.	73
LM End	5.44	Issue Type +	Ma	Location *	LS
Category	Earthen Levee			GPS Latitude/Longitude	
				Start	End
Item	Trim / Thin Trees			37.880085 °	37.880085 °
				-121.333045 °	-121.333045 °
DWR ID	DWR_RD0524_01_s_2012_73				
Comment Code					
T1 : Trim trees to at least five feet above ground level.					
Inspector Comment					
Untrimmed trees on landward slope.

Looking southwest at large untrimmed tree on landward slope.

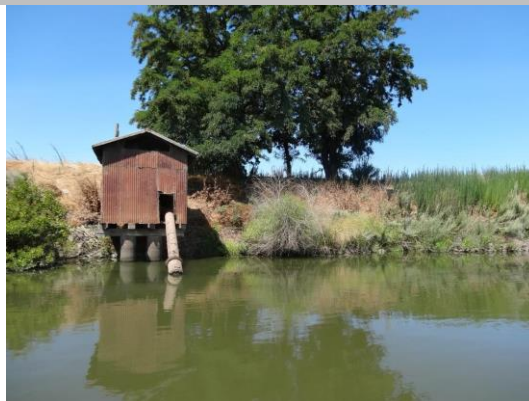
Photo 1 of 2 : SP\_2017\_RD0524\_107\_135\_20170316\_00191.jpg

LM Start	5.53	Rating **	M	Issue No.	135
LM End	5.53	Issue Type +	Ma	Location *	WS
Category	Supplemental			GPS Latitude/Longitude	
				Start	End
Item	DWR Erosion Survey			37.878920 °	37.878920 °
				-121.332670 °	-121.332670 °
DWR ID	DWR_RD0524_01_s_2017_135				
Comment Code					
Inspector Comment					
07/25/2016: No significant change observed.					
06/24/2015: No significant change observed.					
6/19/2014: No significant change observed.					
08/13/2013: Larger trees are at the levee shoulder, and an irrigation pump station is next to the erosion site. [2016 Site ID:RD0524U01RM46.06]

Close view of the site. Note large trees at the levee shoulder.

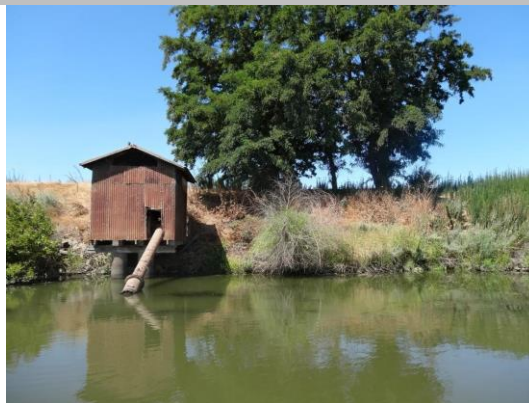
Photo 2 of 2 : SP\_2017\_RD0524\_107\_135\_20170316\_00192.jpg

LM Start	5.53	Rating **	M	Issue No.	135 (cont)
LM End	5.53	Issue Type +	Ma	Location *	WS
Category	Supplemental			GPS Latitude/Longitude	
				Start	End
Item	DWR Erosion Survey			37.878920 °	37.878920 °
				-121.332670 °	-121.332670 °
DWR ID	DWR_RD0524_01_s_2017_135				
Comment Code					
Inspector Comment					
07/25/2016: No significant change observed.					
06/24/2015: No significant change observed.					
6/19/2014: No significant change observed.					
08/13/2013: Larger trees are at the levee shoulder, and an irrigation pump station is next to the erosion site. [2016 Site ID:RD0524U01RM46.06]

Close view of the erosion.

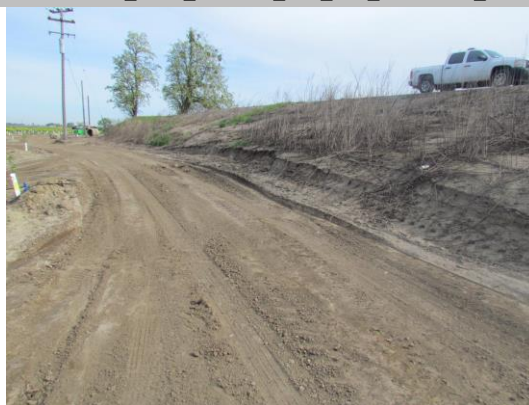
Photo 1 of 2 : SP\_2017\_RD0524\_107\_166\_20170407\_00391.jpg

LM Start	5.56	Rating **	U	Issue No.	166
LM End	5.56	Issue Type +	En	Location *	LS
Category	Earthen Levee			GPS Latitude/Longitude	
				Start	End
Item	Encroachments			37.878333 °	37.878333 °
				-121.332875 °	-121.332875 °
DWR ID	DWR_RD0524_01_s_2017_166				
Comment Code					
AT : Agricultural tilling					
Inspector Comment					
Damaged landward toe appears to be caused by farming activity.

Looking northeast at cut into landward toe.

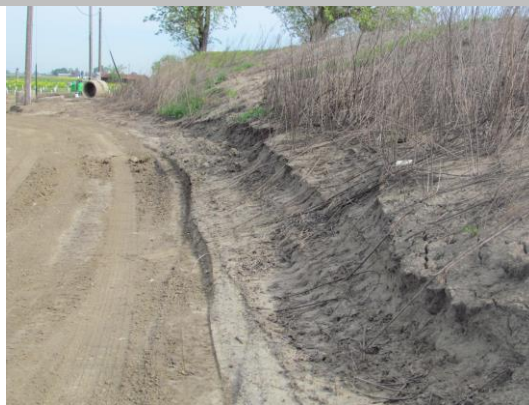
Photo 2 of 2 : SP\_2017\_RD0524\_107\_166\_20170407\_00392.jpg

Looking at north at damage to landward toe.

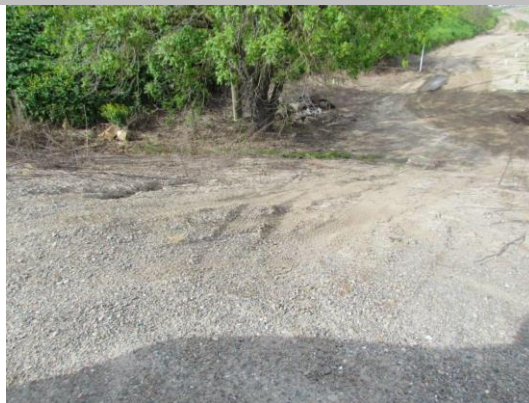
Photo 1 of 1 : SP\_2017\_RD0524\_107\_167\_20170407\_00393.jpg

LM Start	5.58	Rating **	M	Issue No.	167
LM End	5.58	Issue Type +	Ma	Location *	LS
Category	Earthen Levee			GPS Latitude/Longitude	
				Start	End
Item	Slope Stability			37.878115 °	37.878115 °
				-121.332763 °	-121.332763 °
DWR ID	DWR_RD0524_01_s_2017_167				
Comment Code					
S3 : Repair the levee slope damaged by vehicle traffic and prevent access where possible.					
Inspector Comment					
Slope damage caused by vehicle traffic.

Looking west at slope damage caused by vehicle traffic on landward slope.

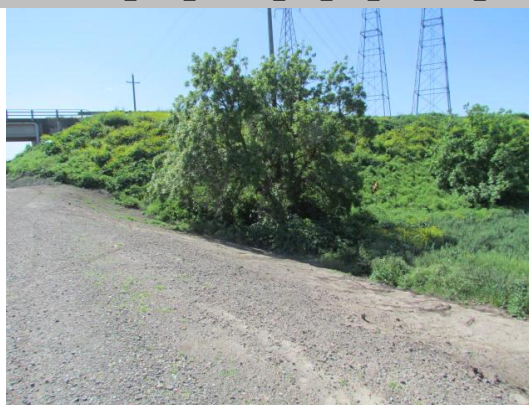
Photo 1 of 2 : SP\_2017\_RD0524\_107\_214\_20170316\_00248.jpg

LM Start	5.58	Rating **	U	Issue No.	214
LM End	5.58	Issue Type +	Ma	Location *	LS
Category	Earthen Levee			GPS Latitude/Longitude	
				Start	End
Item	Vegetation			37.878083 °	37.878083 °
				-121.332717 °	-121.332717 °
DWR ID	DWR_RD0524_01_s_2016_214				
Comment Code					
V2 : Remove the wild growth other than native grasses from the levee slopes.					
Inspector Comment					
Tall weeds, grasses and trees blocking view of landward toe.

Looking west at dense veg at landward toe.

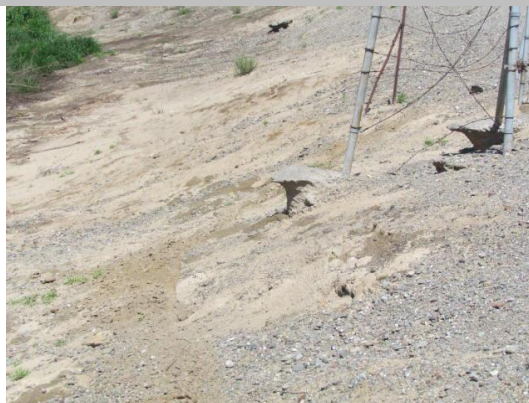
Photo 1 of 3 : SP\_2017\_RD0524\_107\_215\_20170316\_00250.jpg

LM Start	5.64	Rating **	U	Issue No.	215
LM End	5.64	Issue Type +	Ma	Location *	LS
Category	Earthen Levee			GPS Latitude/Longitude	
				Start	End
Item	Slope Stability			37.877378 °	37.877378 °
				-121.332343 °	-121.332343 °
DWR ID	DWR_RD0524_01_s_2016_215				
Comment Code					
S1 : Repair slope instability.					
Inspector Comment					
Levee slope damage is due vehicle traffic and foot traffic. Vehicle traffic created a ramp on landward slope.

Looking north at damage slope on landward slope.

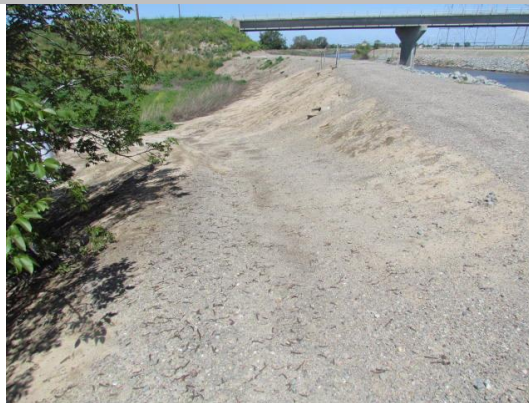
Photo 2 of 3 : SP\_2017\_RD0524\_107\_215\_20170316\_00251.jpg

LM Start	<b>5.64</b>	Rating **	U	Issue No.	<b>215 (cont)</b>
LM End	<b>5.64</b>	Issue Type +	Ma	Location *	LS

Looking north at slope damage (ramp) on landward slope.

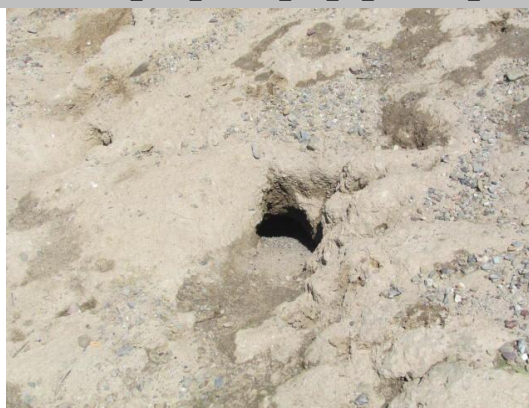
Photo 1 of 2 : SP\_2017\_RD0524\_107\_69\_20170316\_00113.jpg

LM Start	5.64	Rating **	U	Issue No.	69
LM End	5.80	Issue Type +	Ma	Location *	LS
Category	Earthen Levee			GPS Latitude/Longitude	
				Start	End
Item	Animal Control			37.877298 °	37.875073 °
				-121.332343 °	-121.333168 °
DWR ID	DWR_RD0524_01_s_2012_69				
Comment Code					
A3 : No rodents visible, but rodent burrows visible; need to backfill and compact or grout burrows.					
Inspector Comment					
District has grouted rodent holes. But rodents have re-appeared.

Looking south at rodent holes on landward slope.

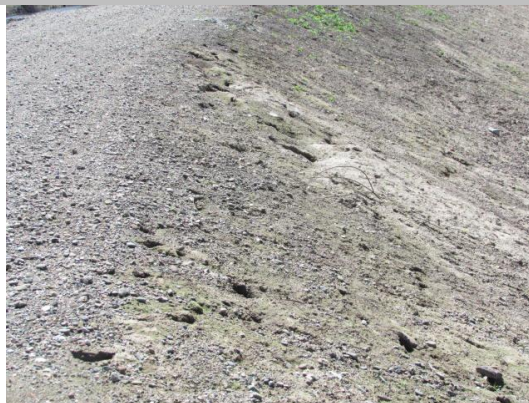
Photo 2 of 2 : SP\_2017\_RD0524\_107\_69\_20170316\_00114.jpg

LM Start	<b>5.64</b>	Rating **	U	Issue No.	<b>69 (cont)</b>
LM End	<b>5.80</b>	Issue Type +	Ma	Location *	LS

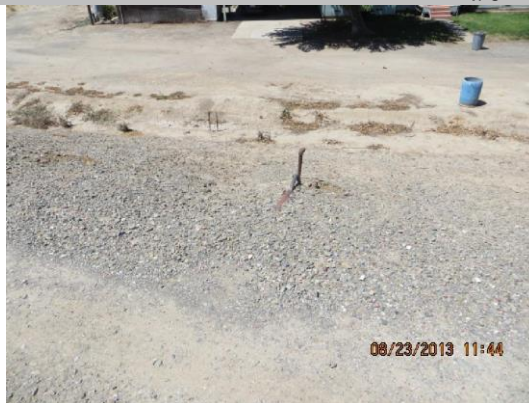
Photo 1 of 2 : UCIP\_SP\_2017\_18364\_30761.jpg

LM Start	5.74	Rating **	M	Issue No.	965
LM End	5.74	Issue Type +	En	Location *	LS
Category	Supplemental			GPS Latitude/Longitude	
				Start	End
Item	DWR UCIP Field Study			37.876001 °	37.876001 °
				-121.332725 °	-121.332725 °
DWR ID					
Comment Code					
Inspector Comment					
FS_ID:18364 DS_ID:20649 EP_NO: N/A Repair Type: Non-Urgent Crossing Status: Found UCIP Comments: Abandoned and should be done so properly. FIELD_STRUCT_DESC: 2.25-inch steel conduit for a 1-inch plastic electrical conduit through the levee 0.25-feet below the crown. Lines exposed on both slopes. FS Date: 8/23/2013

Steel conduit and electrical conduit visible on the LS shoulder.

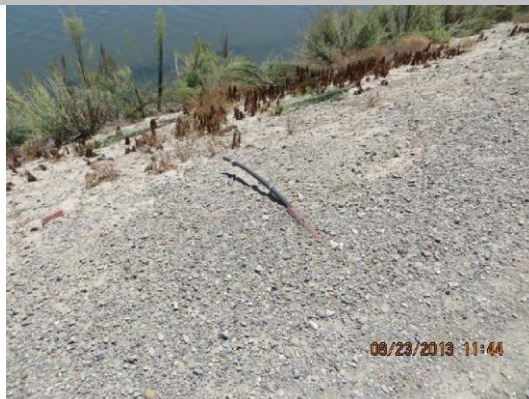
Photo 2 of 2 : UCIP\_SP\_2017\_18364\_30760.jpg

LM Start	<b>5.74</b>	Rating **	M	Issue No.	<b>965 (cont)</b>
LM End	<b>5.74</b>	Issue Type +	En	Location *	LS

Steel conduit and electrical conduit visible on the WS shoulder.

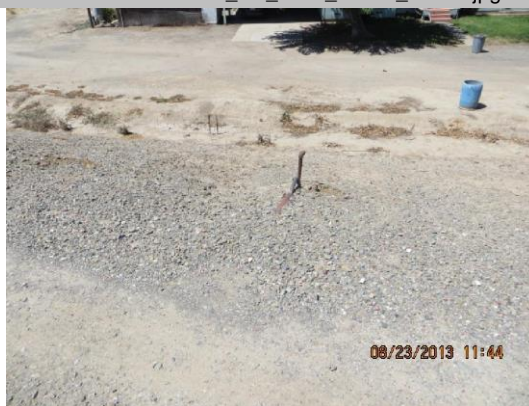
Photo 1 of 1 : UCIP\_SP\_2017\_40793\_30781.jpg

LM Start	5.74	Rating **	M	Issue No.	966
LM End	5.74	Issue Type +	En	Location *	LS
Category	Supplemental			GPS Latitude/Longitude	
				Start	End
Item	DWR UCIP Field Study			37.876001 °	37.876001 °
				-121.332725 °	-121.332725 °
DWR ID					
Comment Code					
Inspector Comment					
FS_ID:40793 DS_ID:20635 EP_NO: N/A Repair Type: Non-Urgent Crossing Status: Indicator Found UCIP Comments: Appears abandoned and if so should be done so properly. No permit identified for this crossing. FIELD_STRUCT_DESC: *ABANDONED* 1-inch steel waterline through the levee 1.0-foot below the crown. Pipe visible only on LS shoulder. FS Date: 8/23/2013

Steel waterline visible on LS shoulder.

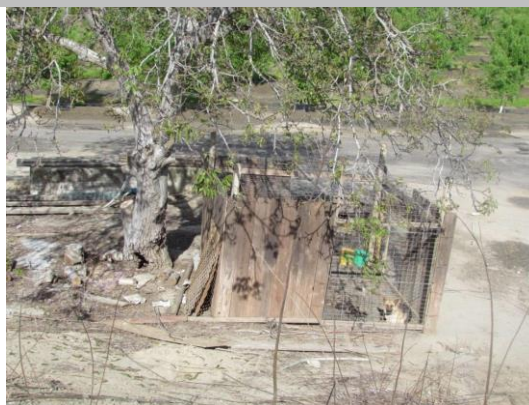
Photo 1 of 1 : SP\_2017\_RD0524\_107\_181\_20170407\_00396.jpg

LM Start	5.77	Rating **	U	Issue No.	181
LM End	5.77	Issue Type +	En	Location *	LS
Category	Earthen Levee			GPS Latitude/Longitude	
				Start	End
Item	Encroachments			37.875545 °	37.875545 °
				-121.332952 °	-121.332952 °
DWR ID	DWR_RD0524_01_s_2017_181				
Comment Code					
BU : Building					
Inspector Comment					
Animal kennel at landside toe.

Looking west at animal pen at landward toe.

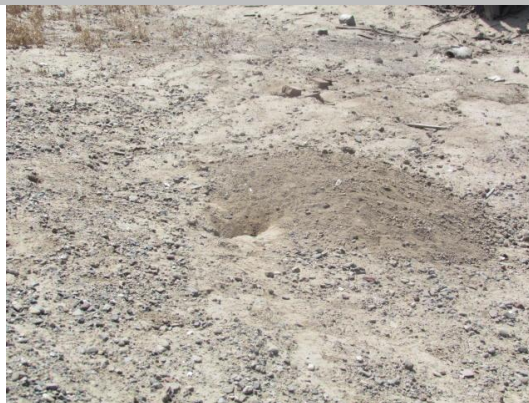
Photo 1 of 2 : SP\_2017\_RD0524\_107\_197\_20170316\_00228.jpg

LM Start	5.77	Rating **	M	Issue No.	197
LM End	5.79	Issue Type +	Ma	Location *	LS
Category	Earthen Levee			GPS Latitude/Longitude	
				Start	End
Item	Animal Control			37.875545 °	37.875310 °
				-121.332952 °	-121.333065 °
DWR ID	DWR_RD0524_01_s_2015_197				
Comment Code					
A1 : Exterminate rodents and backfill and compact or grout burrows.					
Inspector Comment					
Several rodent holes on landward slope and levee crown.

Looking north at typical view of rodent holes on landward slope.

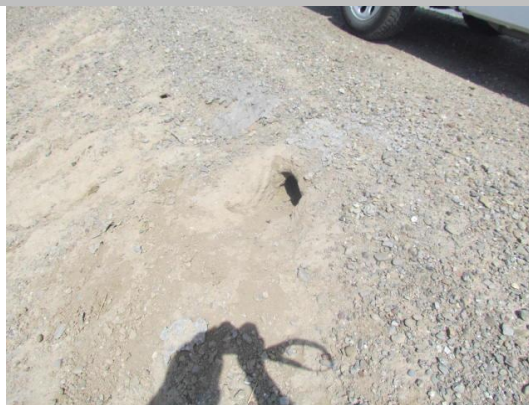
Photo 2 of 2 : SP\_2017\_RD0524\_107\_197\_20170316\_00229.jpg

LM Start	<b>5.77</b>	Rating **	M	Issue No.	<b>197 (cont)</b>
LM End	<b>5.79</b>	Issue Type +	Ma	Location *	LS

Looking southwest at typical view of rodent hole at landward shoulder.

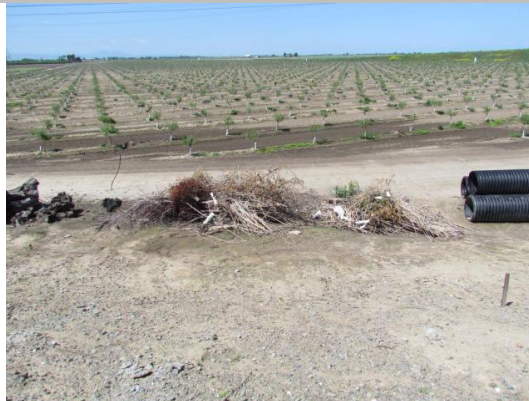
Photo 1 of 1 : SP\_2017\_RD0524\_107\_267\_20170316\_00268.jpg

LM Start	5.79	Rating **	U	Issue No.	267
LM End	5.79	Issue Type +	En	Location *	LS
Category	Earthen Levee			GPS Latitude/Longitude	
				Start	End
Item	Encroachments			37.875328 °	37.875328 °
				-121.333050 °	-121.333050 °
DWR ID	DWR_RD0524_01_s_2012_267				
Comment Code					
PR : Prunings					
Inspector Comment					
Prunings at landside toe should be burned or removed.

Looking west at prunings at landward toe.

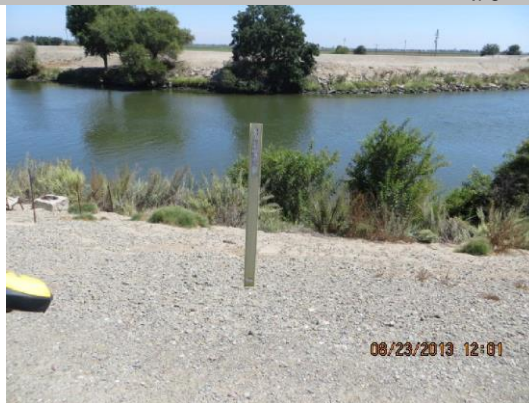
Photo 1 of 1 : UCIP\_SP\_2017\_18705\_31249.jpg

LM Start	5.82	Rating **	M	Issue No.	968
LM End	5.82	Issue Type +	En	Location *	WS
Category	Supplemental			GPS Latitude/Longitude	
				Start	End
Item	DWR UCIP Field Study			37.874829 °	37.874829 °
				-121.333265 °	-121.333265 °
DWR ID					
Comment Code					
Inspector Comment					
FS_ID:18705 DS_ID:20656 EP_NO: N/A Repair Type: Non-Urgent Crossing Status: Indicator Found UCIP Comments: Need to verify gasline exists and if so improve signage. FIELD_STRUCT_DESC: Gasline marker sign on WS shoulder. FS Date: 8/23/2013

Gasline marker on WS shoulder.

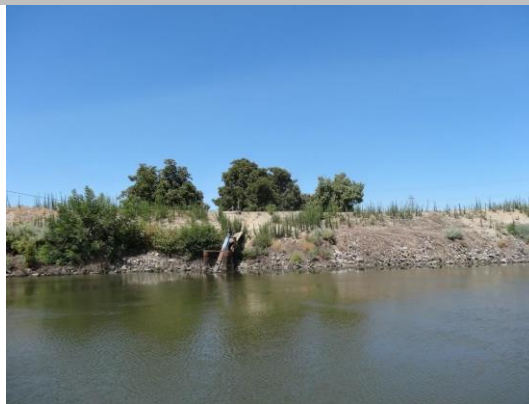
Photo 1 of 2 : SP\_2017\_RD0524\_107\_139\_20170316\_00194.jpg

LM Start	5.86	Rating **	U	Issue No.	139
LM End	5.86	Issue Type +	Ma	Location *	WS
Category	Supplemental			GPS Latitude/Longitude	
				Start	End
Item	DWR Erosion Survey			37.874370 °	37.874370 °
				-121.332850 °	-121.332850 °
DWR ID	DWR_RD0524_01_s_2017_139				
Comment Code					
Inspector Comment					
07/25/2016: No significant change observed.					
06/24/2015: No significant change observed.					
06/19/2014: No significant change observed.					
08/13/2013: No significant change observed.					
08/07/2012: The erosion is near a water-intake structure. Pipe leakage likely caused the erosion. [2016 Site ID:RD0524U01RM46.39]

Close view of the erosion and the pipe on the site.

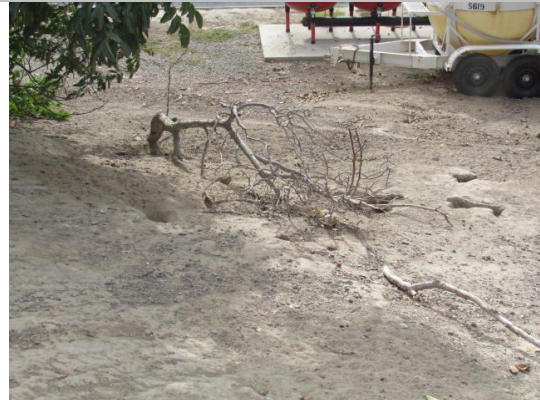
Photo 1 of 2 : SP\_2017\_RD0524\_107\_75\_20170316\_00122.jpg

LM Start	5.86	Rating **	M	Issue No.	75
LM End	5.88	Issue Type +	Ma	Location *	WS
Category	Earthen Levee			GPS Latitude/Longitude	
				Start	End
Item	Animal Control			37.874240 °	37.874002 °
				-121.333187 °	-121.333027 °
DWR ID	DWR_RD0524_01_s_2012_75				
Comment Code					
A1 : Exterminate rodents and backfill and compact or grout burrows.					
Inspector Comment					
District has grouted rodent holes, but other rodent holes have appeared. Active rodents in area

Looking typical view of several rodent holes on landward slope and toe.

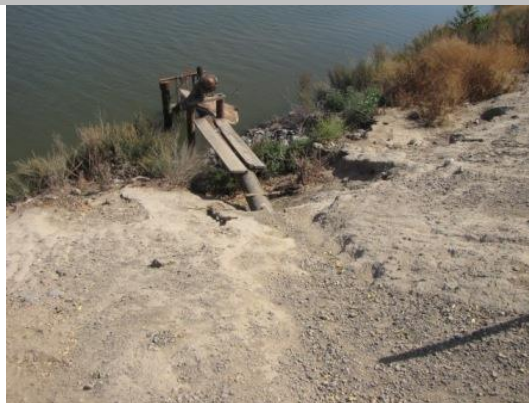
Photo 1 of 3 : SP\_2017\_RD0524\_107\_74\_20170316\_00119.jpg

LM Start	5.86	Rating **	U	Issue No.	74
LM End	5.87	Issue Type +	Ma	Location *	WS
Category	Earthen Levee			GPS Latitude/Longitude	
				Start	End
Item	Erosion / Bank Caving			37.874240 °	37.874165 °
				-121.333185 °	-121.333155 °
DWR ID	DWR_RD0524_01_s_2012_74				
Comment Code					
E1 : Note and monitor erosion site.					
Inspector Comment					
Erosion on landward slope around intake pipe.

Looking southeast at erosion around pipe.

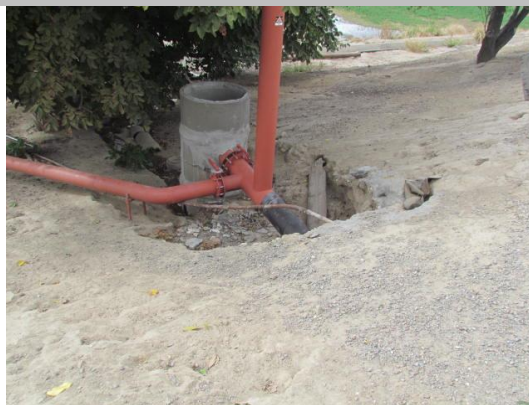
Photo 2 of 3 : SP\_2017\_RD0524\_107\_74\_20170316\_00120.jpg

LM Start	<b>5.86</b>	Rating **	U	Issue No.	<b>74 (cont)</b>
LM End	<b>5.87</b>	Issue Type +	Ma	Location *	WS

Looking west at erosion around intake pipe on landward slope.

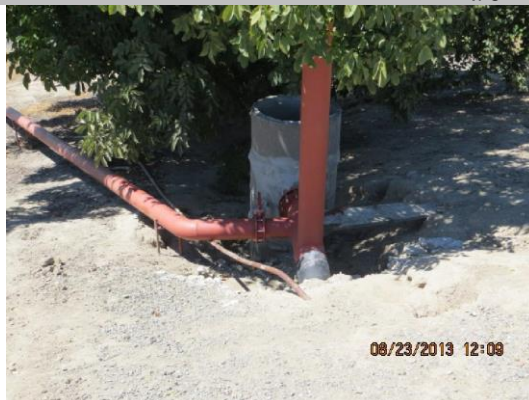
Photo 1 of 3 : UCIP\_SP\_2017\_18379\_30829.jpg

LM Start	5.87	Rating **	M	Issue No.	969
LM End	5.87	Issue Type +	En	Location *	WS
Category	Supplemental			GPS Latitude/Longitude	
				Start	End
Item	DWR UCIP Field Study			37.874194 °	37.874194 °
				-121.333182 °	-121.333182 °
DWR ID					
Comment Code					
Inspector Comment					
FS_ID:18379 DS_ID:20638 EP_NO: N/A Repair Type: Non-Urgent Crossing Status: Found UCIP Comments: Heavy erosion around pipe upstream of standpipe on LS slope. Verify pipe is not leaking and repair erosion on LS slope. FIELD_STRUCT_DESC: 12-inch steel irrigation pipe through the levee 10.0 feet below the crown. Slant pump on pier at WS toe. 10-inch steel standpipe on LS slope. 42-inch concrete standpipe on LS slope. Filter plant, and power pole on LS toe. 1.5-inch galvanized iron electrical conduit at same location. Originally included in the 1964 O&M manual. FS Date: 8/23/2013

Butterfly valves and standpipes on LS slope along with electrical conduit.

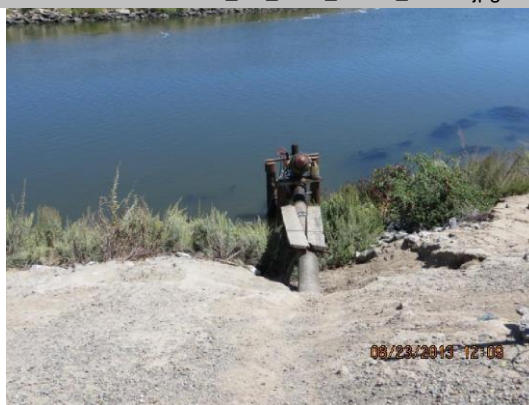
Photo 2 of 3 : UCIP\_SP\_2017\_18379\_30828.jpg

LM Start	<b>5.87</b>	Rating **	M	Issue No.	<b>969 (cont)</b>
LM End	<b>5.87</b>	Issue Type +	En	Location *	WS

Slant pump on WS toe.

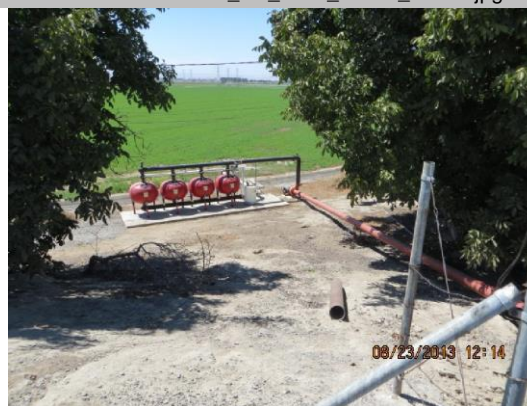
Photo 3 of 3 : UCIP\_SP\_2017\_18379\_30827.jpg

LM Start	5.87	Rating **	M	Issue No.	969 (cont)
LM End	5.87	Issue Type +	En	Location *	WS
Category	Supplemental			GPS Latitude/Longitude	
				Start	End
Item	DWR UCIP Field Study			37.874194 °	37.874194 °
				-121.333182 °	-121.333182 °
DWR ID					
Comment Code					
Inspector Comment					
FS_ID:18379 DS_ID:20638 EP_NO: N/A Repair Type: Non-Urgent Crossing Status: Found UCIP Comments: Heavy erosion around pipe upstream of standpipe on LS slope. Verify pipe is not leaking and repair erosion on LS slope. FIELD_STRUCT_DESC: 12-inch steel irrigation pipe through the levee 10.0 feet below the crown. Slant pump on pier at WS toe. 10-inch steel standpipe on LS slope. 42-inch concrete standpipe on LS slope. Filter plant, and power pole on LS toe. 1.5-inch galvanized iron electrical conduit at same location. Originally included in the 1964 O&M manual. FS Date: 8/23/2013

Filter pump on LS toe.

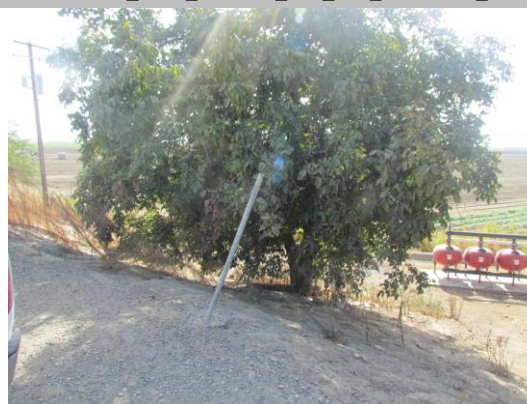
Photo 1 of 1 : SP\_2017\_RD0524\_107\_217\_20170316\_00254.jpg

LM Start	5.87	Rating **	U	Issue No.	217
LM End	5.87	Issue Type +	Ma	Location *	LS
Category	Earthen Levee			GPS Latitude/Longitude	
				Start	End
Item	Trim / Thin Trees			37.874090 °	37.874090 °
				-121.333162 °	-121.333162 °
DWR ID	DWR_RD0524_01_s_2016_217				
Comment Code					
T1 : Trim trees to at least five feet above ground level.					
Inspector Comment					
Untrimmed walnut tree on landward slope.

Looking west at walnut tree on landward slope.

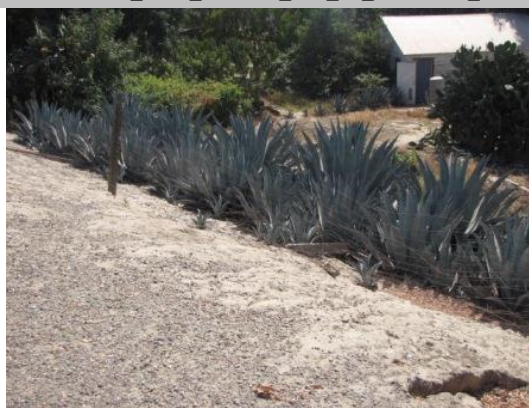
Photo 1 of 1 : SP\_2017\_RD0524\_107\_88\_20170316\_00141.jpg

LM Start	5.94	Rating **	U	Issue No.	88
LM End	5.95	Issue Type +	En	Location *	LS
Category	Earthen Levee			GPS Latitude/Longitude	
				Start	End
Item	Vegetation			37.873543 °	37.873445 °
				-121.332308 °	-121.332127 °
DWR ID	DWR_RD0524_01_s_2012_88				
Comment Code					
V6 : Landscaping					
Inspector Comment					
Cactus and Century plants on landward slope and toe.

Looking southeast at fence and cactus on landside slope and toe.

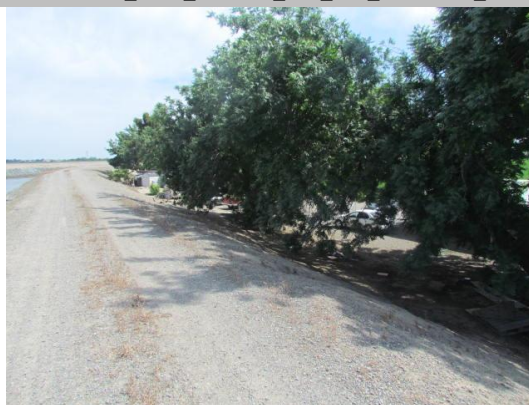
Photo 1 of 1 : SP\_2017\_RD0524\_107\_120\_20170316\_00182.jpg

LM Start	5.96	Rating **	U	Issue No.	120
LM End	5.96	Issue Type +	Ma	Location *	LS
Category	Earthen Levee			GPS Latitude/Longitude	
				Start	End
Item	Trim / Thin Trees			37.873347 °	37.873347 °
				-121.332028 °	-121.332028 °
DWR ID	DWR_RD0524_01_s_2012_120				
Comment Code					
T1 : Trim trees to at least five feet above ground level.					
Inspector Comment

Looking south at untrimmed trees on landward slope and toe.

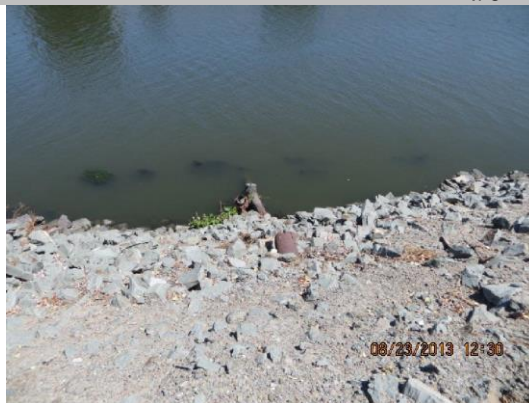
Photo 1 of 2 : UCIP\_SP\_2017\_18392\_30910.jpg

LM Start	6.15	Rating **	M	Issue No.	970
LM End	6.15	Issue Type +	En	Location *	LS
Category	Supplemental			GPS Latitude/Longitude	
				Start	End
Item	DWR UCIP Field Study			37.871138 °	37.871138 °
				-121.330146 °	-121.330146 °
DWR ID					
Comment Code					
Inspector Comment					
FS_ID:18392					
DS_ID:20641					
EP_NO: N/A					
Repair Type: Non-Urgent					
Crossing Status: Found					
UCIP Comments: Pipe and pump abandoned and should be done so properly.					
FIELD_STRUCT_DESC: *ABANDONED*10-inch pipe through levee 12.0 feet below crown, pump on the waterward slope. Originally included in the 1964 O&M manual.					
FS Date: 8/23/2013

Pump and open pipe visible on WS slope.

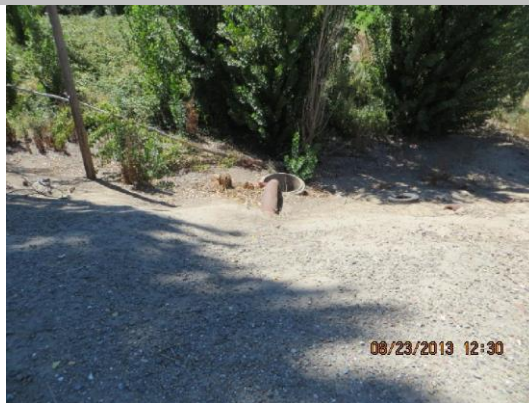
Photo 2 of 2 : UCIP\_SP\_2017\_18392\_30909.jpg

Pipe and concrete standpipe visible on LS toe.

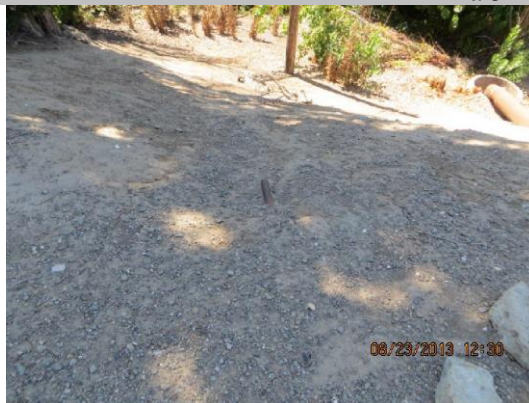
Photo 1 of 2 : UCIP\_SP\_2017\_22073\_37670.jpg

LM Start	6.15	Rating **	M	Issue No.	971
LM End	6.15	Issue Type +	En	Location *	LS
Category	Supplemental			GPS Latitude/Longitude	
				Start	End
Item	DWR UCIP Field Study			37.871118 °	37.871118 °
				-121.330137 °	-121.330137 °
DWR ID					
Comment Code					
Inspector Comment					
FS_ID:22073 DS_ID:24052 EP_NO: N/A Repair Type: Non-Urgent Crossing Status: Found UCIP Comments: Abandoned and should be done so properly. FIELD_STRUCT_DESC: *ABANDONED* 1.75-inch galvanized iron electrical conduit through the levee 1-foot below the crown. Power pole on LS toe. FS Date: 8/23/2013

Pipe visible on LS slope.

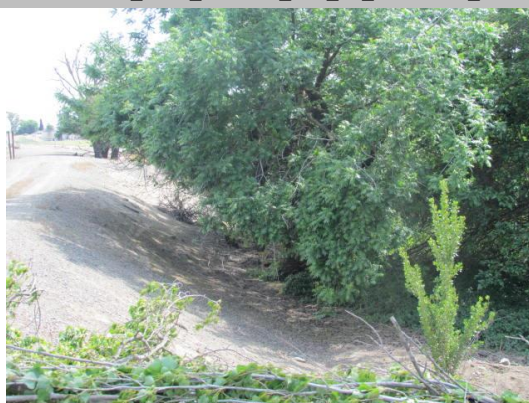
Photo 1 of 1 : SP\_2017\_RD0524\_107\_98\_20170316\_00157.jpg

LM Start	6.17	Rating **	U	Issue No.	98
LM End	6.17	Issue Type +	Ma	Location *	LS
Category	Earthen Levee			GPS Latitude/Longitude	
				Start	End
Item	Trim / Thin Trees			37.870842 °	37.870842 °
				-121.330000 °	-121.330000 °
DWR ID	DWR_RD0524_01_s_2012_98				
Comment Code					
T1 : Trim trees to at least five feet above ground level.					
Inspector Comment

Looking southeast at untrimmed trees at landward toe.
